QUICK FACTS

THE ISSUE

THE RESOLUTION

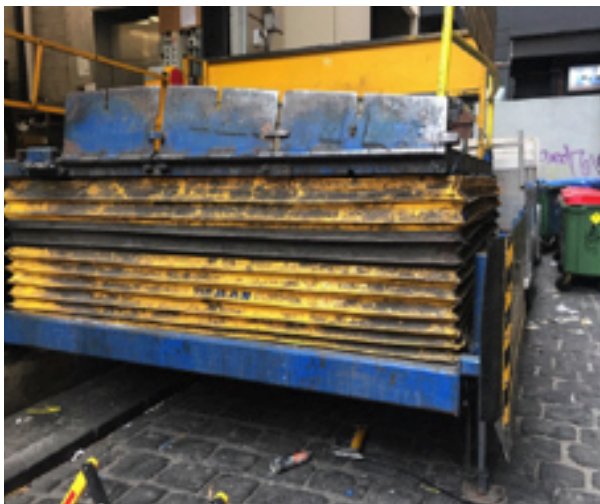
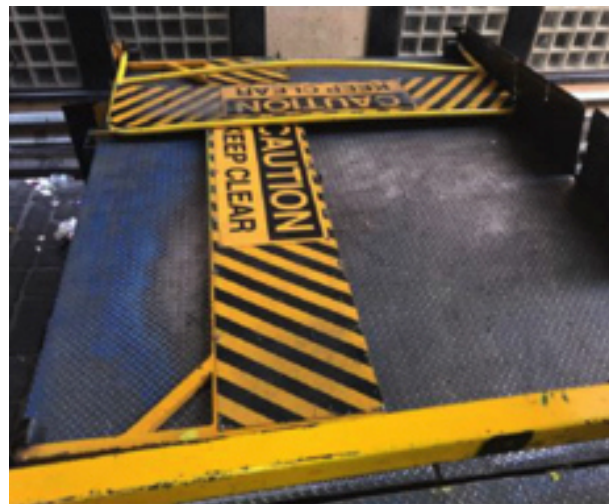
BEFORE PHOTOS

This scissor lift unit is continually breaking the gate system because of the way it had to be lowered due to the storage of the railing. Additionally, it was challenging to unload trucks due to the narrowness of flap area obstructed by the railing. A B Equipment contacted our client and met with their Field Operations Supervisor to discuss a resolution.

Our Client and A B Equipment came to a decision the deck should be widened and have a permanent fixed rail. Additionally, installation of a kick rail was required to make the safety of the unit operationally compliant, and therefore safer for the operators.

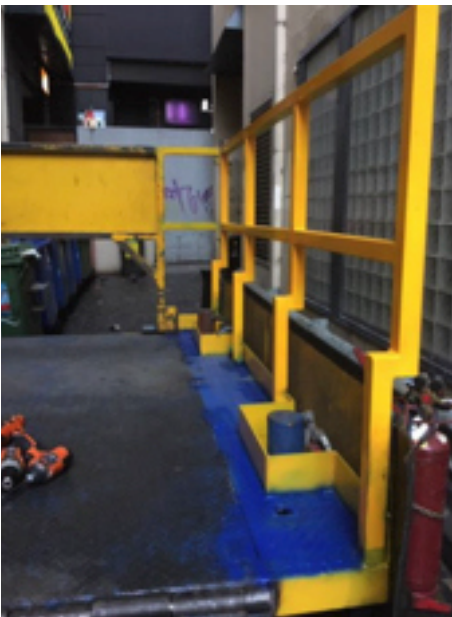
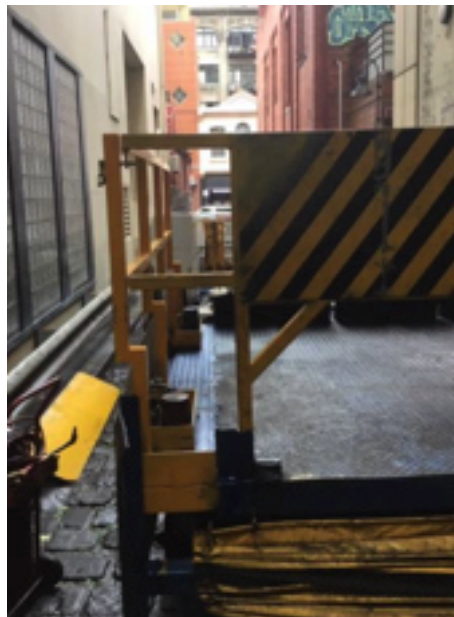
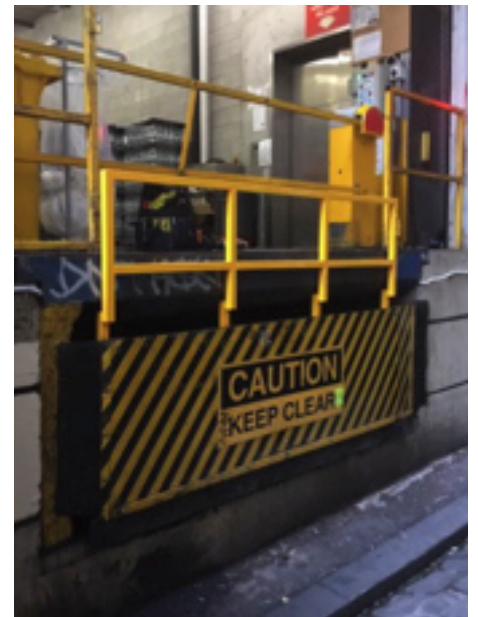
AFTER PHOTOS

The solution eliminated the need to lift the rail into position each time the unit was in use. It also allowed for more space at the front of the lift table, giving access to the first pallet on a truck.
