CASE STUDY NO 18

8 Pallet Scissor Lift

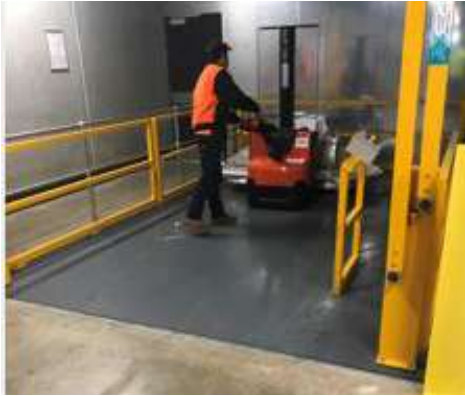
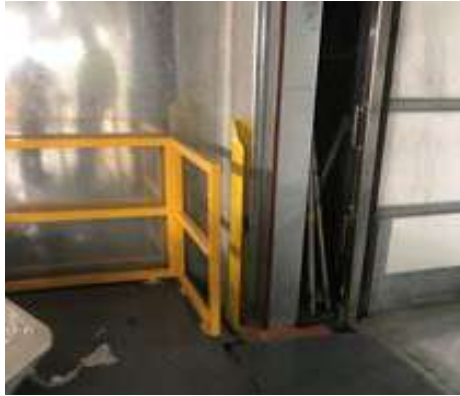
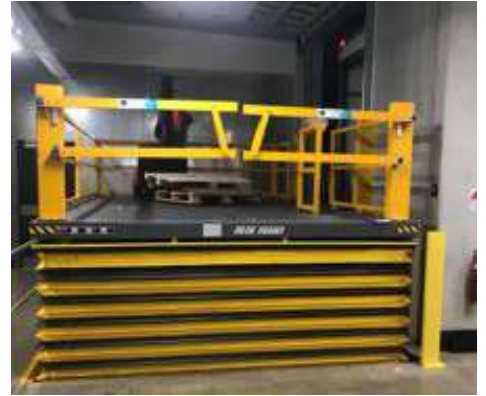
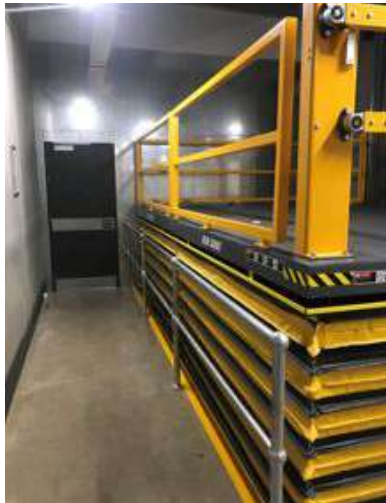
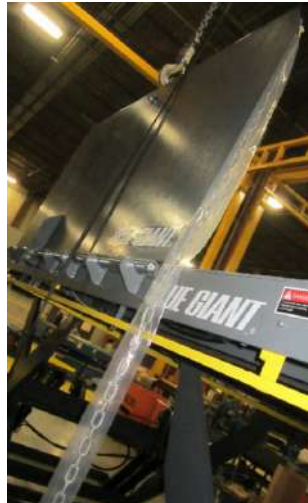
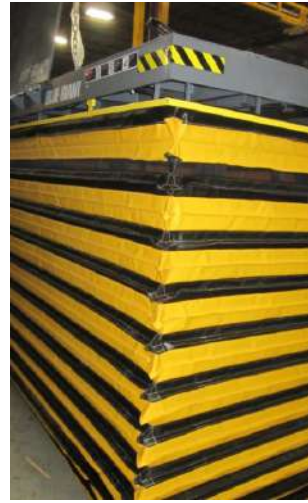
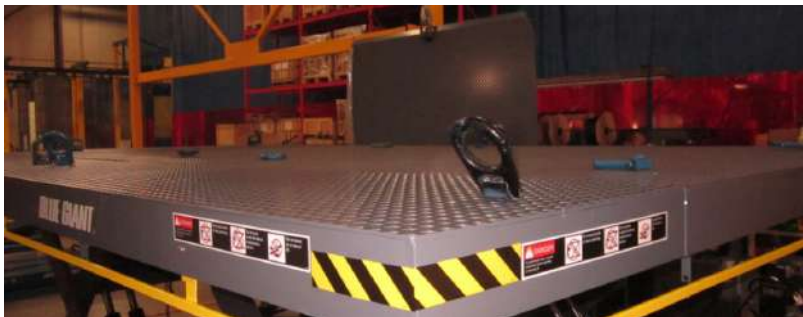
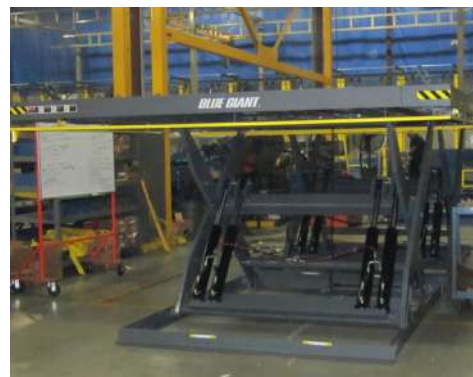
AFTER PHOTOS

An eight Pallet Scissor lift was required with minimal space within the stockroom due to the stockroom layout. Due to the positioning of the doorway opening, the unit could not be installed as a one-piece unit. The unit also required a longer reach on the flap, due to the wall that was needed to be cleared before being able to sit on the trailers to unload their product.

A B Equipment was able to supply and place two units and attach them as one, therefore, giving the customer an eight pallet Scissor Lift. A B Equipment also installed a 1100mm flap fitted to the side of the scissor lift. This gave the customer the reach required and a Lift with greater lifting capacity; allowing us to position the Scissor Lift table in a way that allowed clear access and pathways within the stockroom.
