## CASE STUDY NO 20

### Goods Lift and Scissor Lift

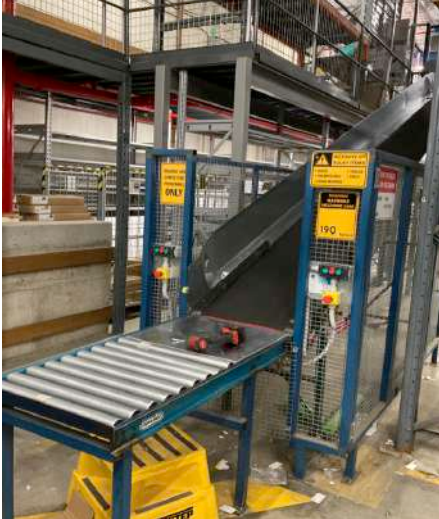
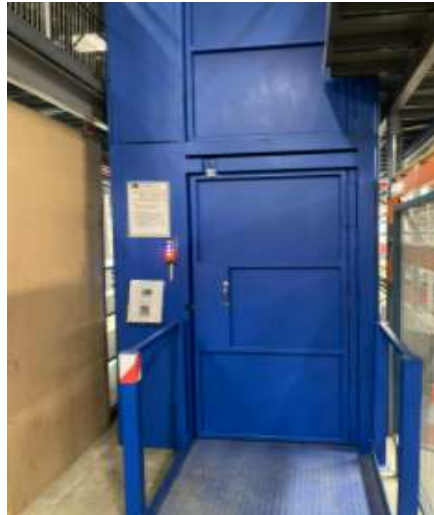
**BEFORE PHOTOS GOODS  
LIFT LOCATION**

The store had a fire at the back dock necessitating the replacement of their scissor lift. The dock leveller and conveyor also required to be removed and replaced due to water damage from the sprinkler system and smoke damage.

Difficulties were faced working in with staff so trade would not be affected. This involved the removal of the mezzanine floor sections to fit the goods lift and reposition floor bracing to support the mezzanine floor.

A B Equipment were able to manufacture and install a new goods lift in place of the conveyor. Offering a safer and faster transfer of stock to the mezzanine level of the store.
